# **Bus Industry Safety Council Summer Meeting 2018**

Baltimore, MD  
June 26-27, 2018

*Loretta G. Bitner, Chief  
Commercial Passenger Carrier Safety Division  
Office of Enforcement and Compliance*

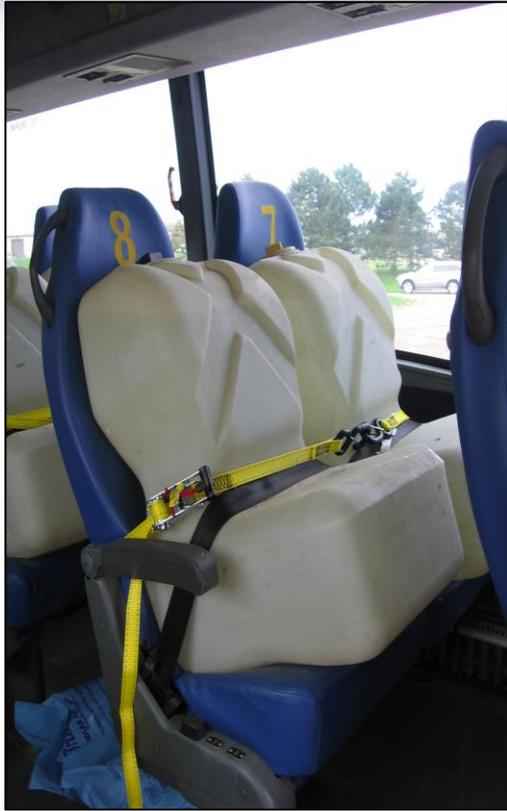
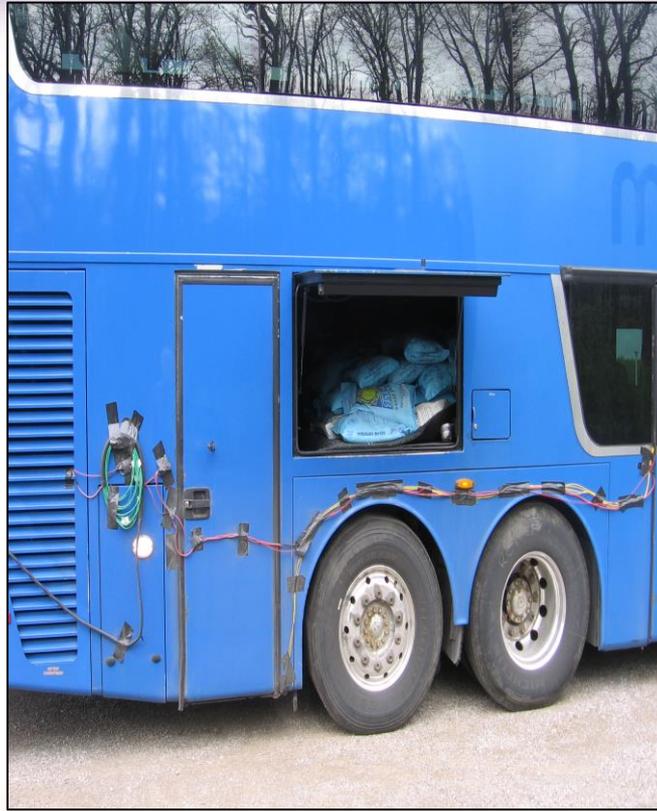
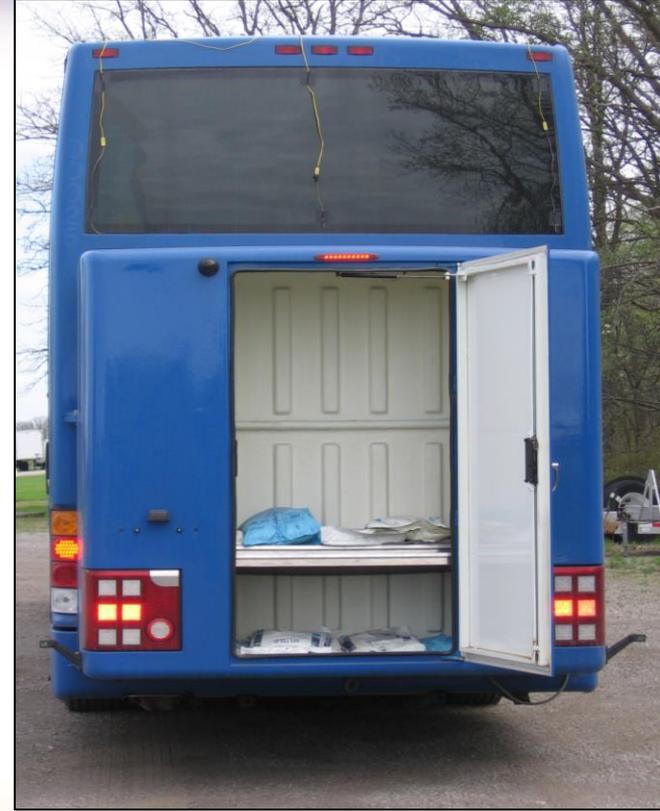
# Safety Study of Double-Decker Motorcoaches with Rear Luggage Compartment

The study was conducted through a combination of analysis and tests in 3 loading conditions:

- **Reference** – ballast for a full load of passengers and their normal luggage without a rear luggage compartment;
- **Regulatory** - same amount of ballast and a rear luggage compartment attached; and
- **Maximum** - weighted to gross vehicle weight rating (GVWR) with a rear luggage compartment attached.

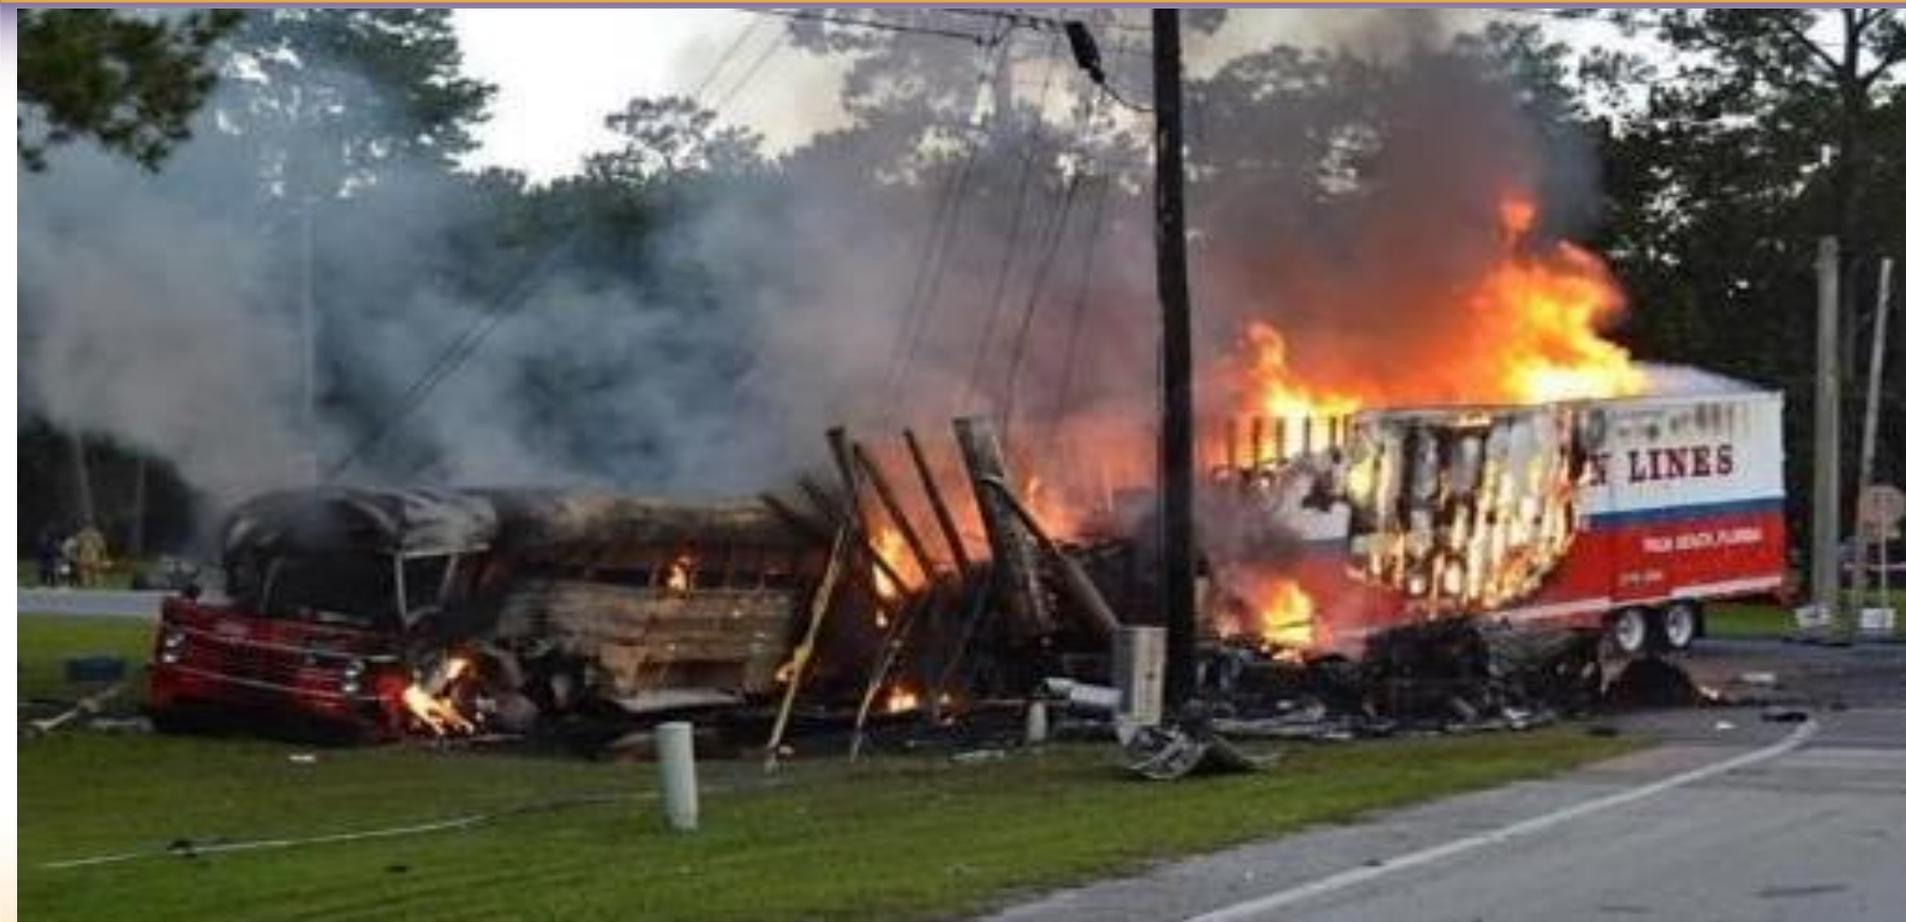
# Migrant Agricultural Worker Transportation

- On July 2, 2016, about 5:16 a.m., a 1979 Blue Bird bus, operated by Billy R. Evans Harvesting, Inc., was traveling south on State Road 363, near St. Marks, Florida.
- It was struck by a westbound 2005 Freightliner, operated by Verity Van Lines, Inc., at the intersection of US-98 and SR 363.

- The bus driver had failed to stop at the intersection.
  - On SR 363, traffic was controlled by a stop sign and overhead flashing red traffic control beacons.
  - Overhead flashing yellow traffic control beacons controlled traffic on US-98.
- The truck struck the left side of the bus, resulting in the rapid counterclockwise rotation of the truck and the breach of its right-side-mounted diesel fuel tank, which ignited a fire.
- The front of the semitrailer then struck the left side of the bus.

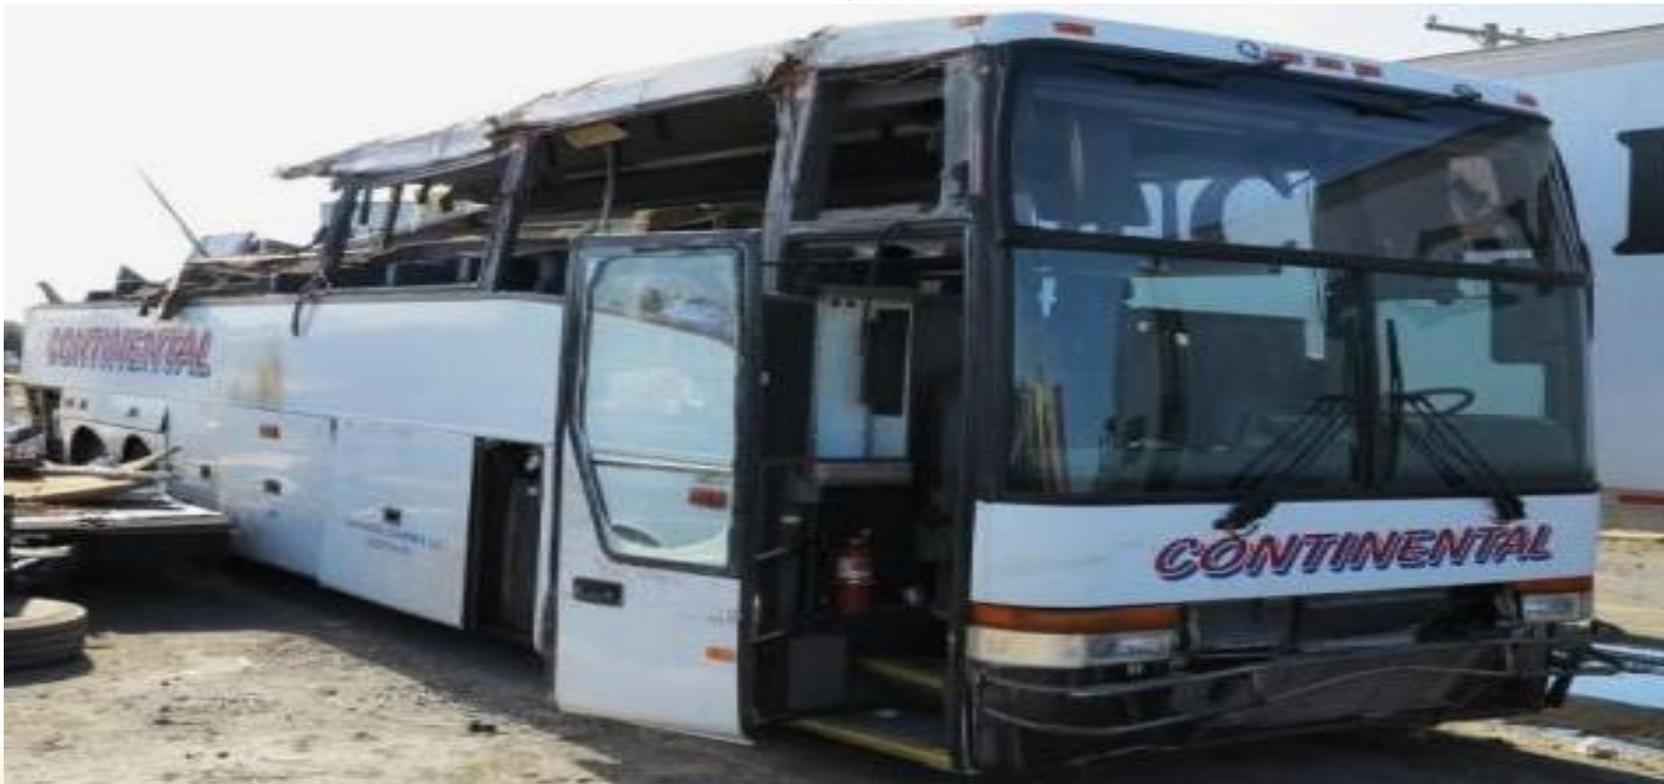
Little Rock, Arkansas

- At 12:55 am, a motorcoach operated by Vasquez Citrus and Hauling, occupied by a 28-year-old driver, codriver, and 20 AG workers, was traveling west on I-40.
- The motorcoach departed the roadway, crossed rumble strips, traveled about 640 feet along the paved shoulder, and collided with a concrete barrier.

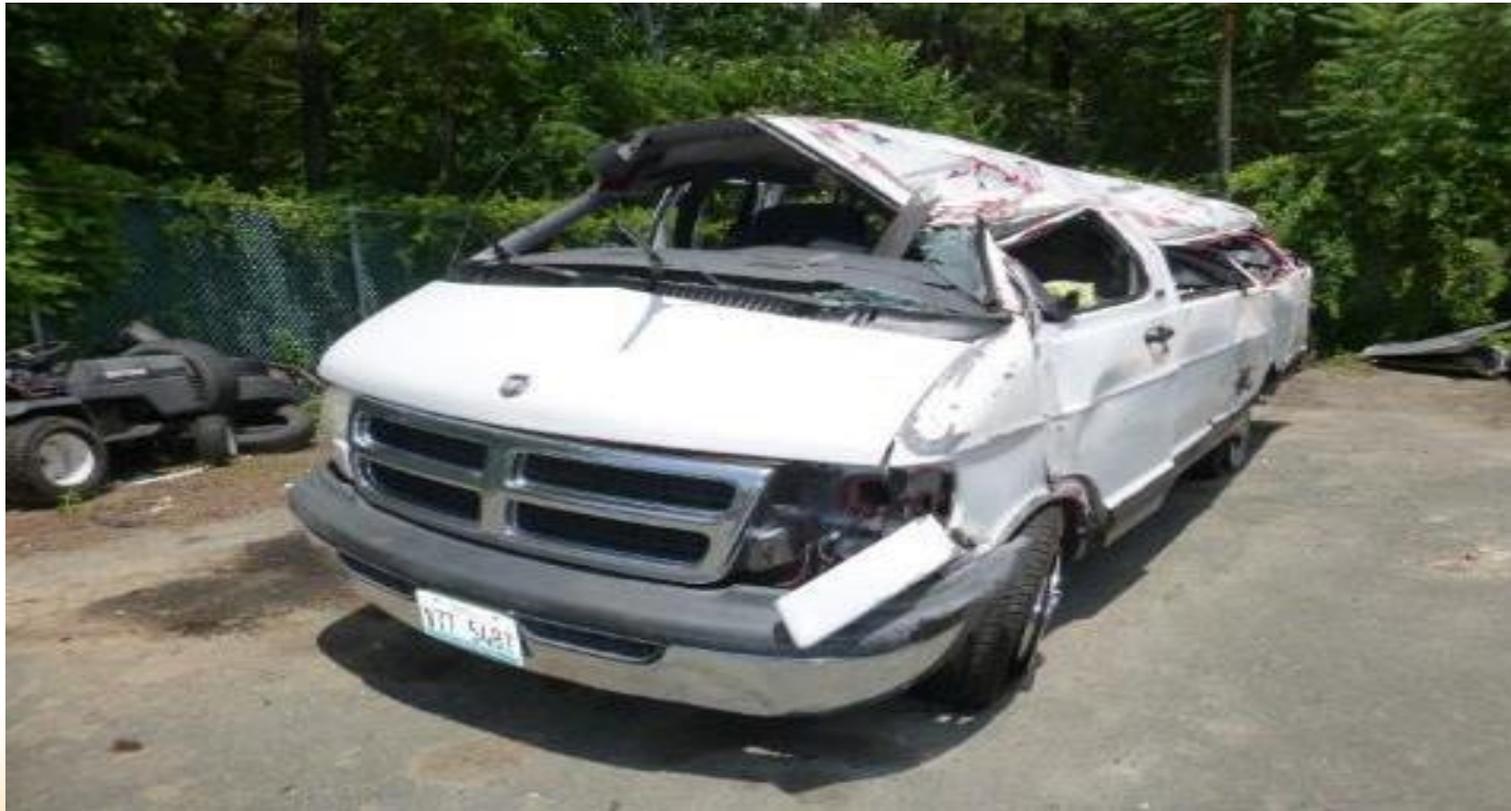
Ruther Glen, Virginia

- At 12:35 am, a 15-passenger van occupied by a 50-year-old driver and 15 passengers, most of whom were migrant agricultural workers, was traveling north on I-95 to NJ.
- The van departed the roadway onto the left shoulder, swerved right across all three lanes striking a passenger car and swinging out of the roadway onto the grass, overturned at least two times.
